<h1 style="text-align: center;">TSB-Local</h1>	<b>Model</b>	Sorento [BL](2006MY), Sorento [BL](2007MY)
	<b>Group</b>	Fuel System(14)
	<b>TSB No.</b>	JC039 / AS160;C21VA
<b>Subject</b>  <h2 style="text-align: center;">Injector Seal Replacement</h2>	<b>Published</b>	4/15/2010
	<b>TSB Type</b>	Service Action
	<b>Area &amp; Distributor</b>	U.K (C21VA)

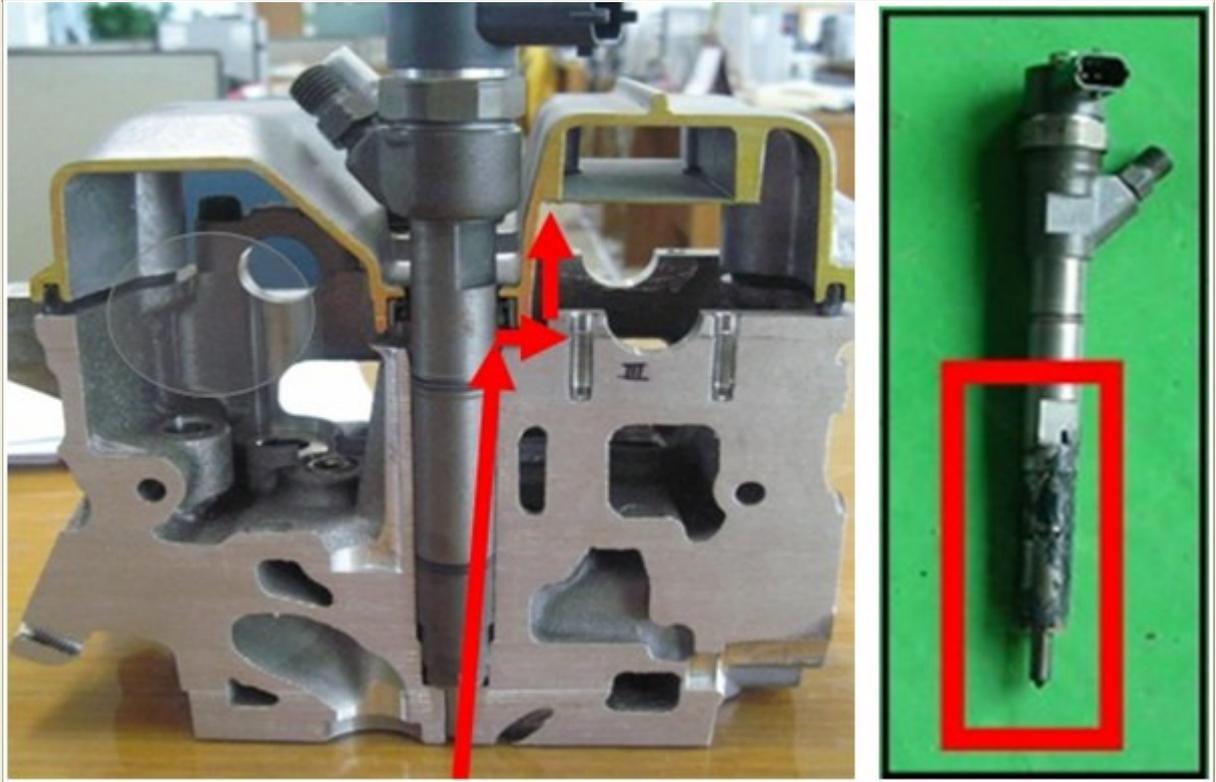
## Gas leaks from injector & cylinders

Combustion gases leaking from the cylinder due to insufficient sealing of the copper injector seals is mixing with engine oil in the engine head cover. The result is a possible deterioration in the quality of engine oil, the oil strainer may become blocked and subsequently the oil supply to the turbo is restricted causing the turbo bearings to fail. (this is the worst case scenario)

For all affected vehicles, remove each injector and thoroughly clean the injector bodies and injector mounting holes in the cylinder head, replace the injector seals following the Service Procedure below.

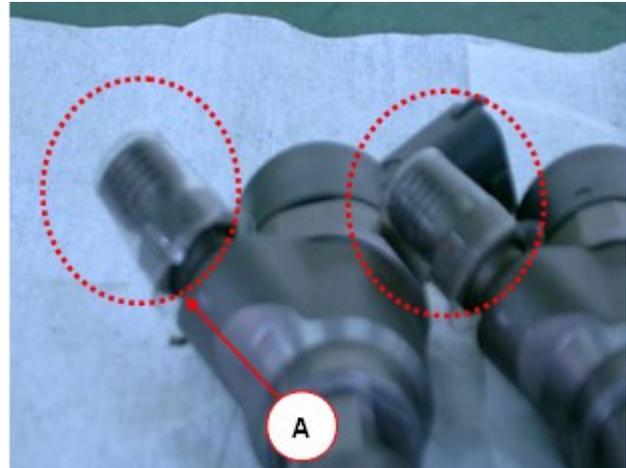
2. Plug caps (A) (these can be found in the CRDI Test Kit) onto the inlets of all the removed injectors as shown on the photo to prevent foreign materials from entering into the injectors.

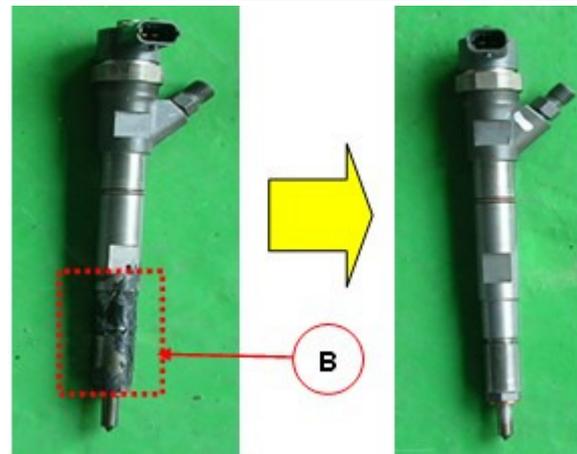
3. With alcohol cleanser clean off carbon deposits from the injector body (B).

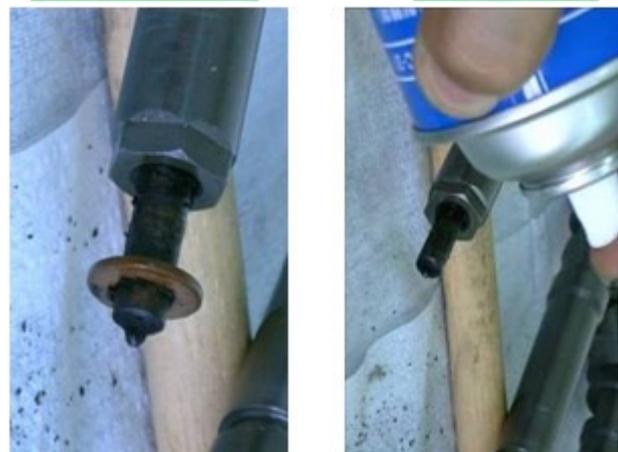
4. Remove the injector seal from the injector nozzle.

5. Spray cleaner on the injector nozzle.

6. With a clean fabric cloth remove carbon deposits from the injector nozzle.

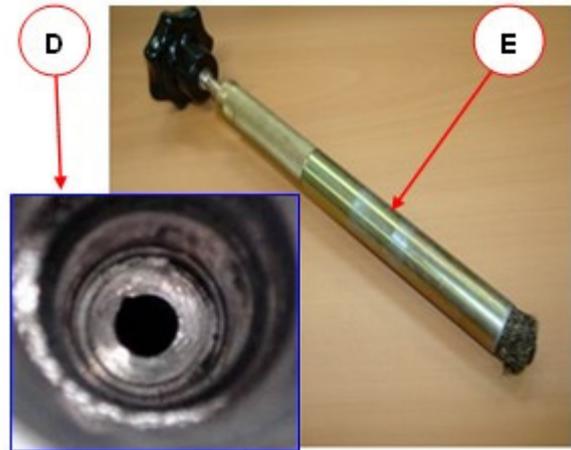
7. Using the SST (E) remove carbon deposits from injector mounting holes (D) in the engine head assembly.

\* SST  
: 0935127300 (injector hole cleaning brush)

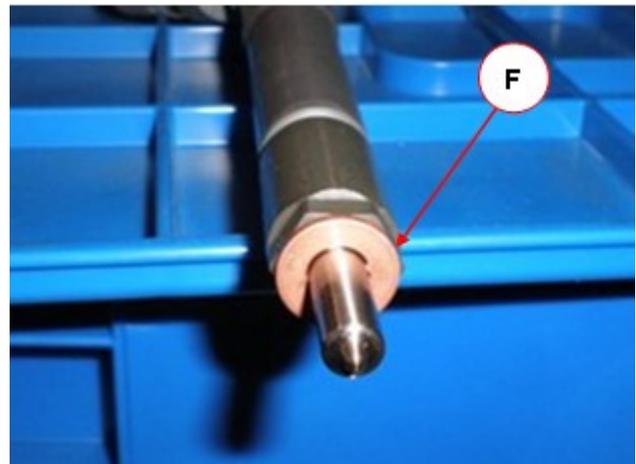
8. Insert a new injector seal (F) to each injector nozzle and reinstall all the removed injectors.

**Caution**  
When tightening injector clamp bolts, make sure to use the specified torque.

**Tightening torque**  
2.9~3.4 kgf-m (28.4~33.3 N-m, 21.0~24.6 lbf-ft)
